STATE OF NORTH CAROLINA
CHATHAM COUNTY
STRATA SOLAR, LLC,

ERICO INTERNATIONAL CORPORATION,

COMPLAINT FOR DAMAGES (jury trial demanded)

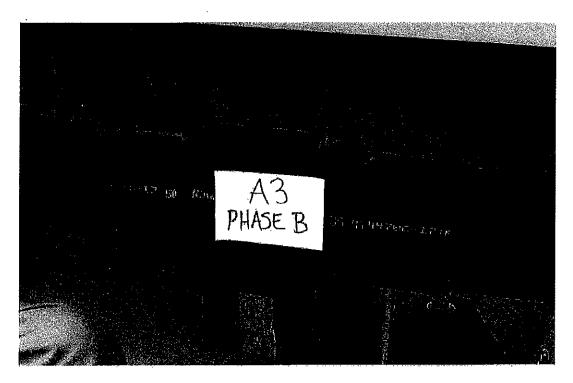
- 31. The sleeving system involved the use of a black polymer sleeve that would be placed around the two metal plates and four bolts that comprised the make-shift clamp splicing system, whereby the black polymer sleeve was heated externally to shrink wrap the sleeve around the splice as insulation.
- 32. Below is a photograph of how the sleeving system would appear after it had been shrink wrapped onto the make-shift clamp splicing system, this photo having been taken at station at issue, before the subject event:

- 33. This shrink wrap process, however, did not account for whether there might be damage to the sleeving system by virtue of the sharp edges of the metal clamps or bolts that comprised the make-shift clamping system.
- 34. ERICO apparently did not design or provide or recommend anything to protect the edges of the bolts.
